Slurry Wall

Leigh Reservoir

NEAR TAUNTON, SOMERSET, UK

Sealing small leak through shoulder of dam embankment

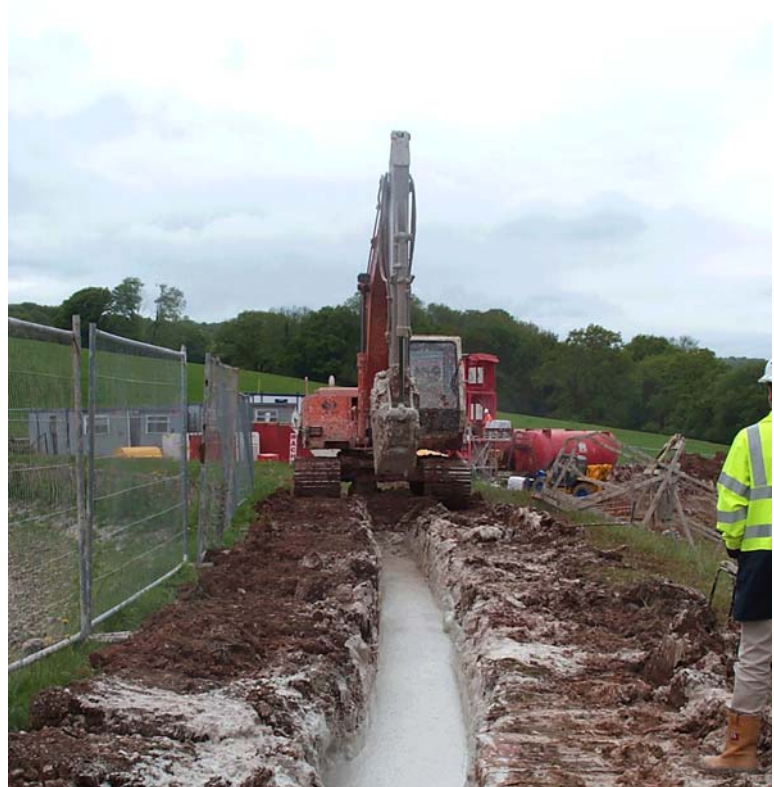
Excavation progressing along dam crest

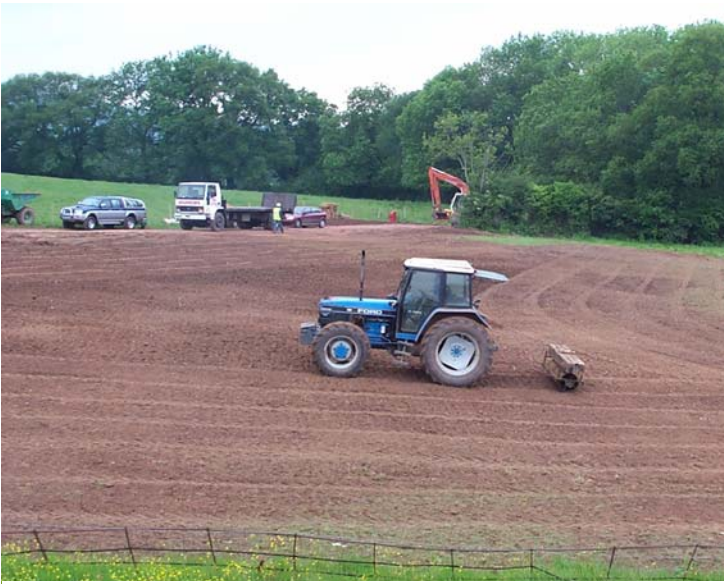
Remediation of Bachy Soletanche working compound

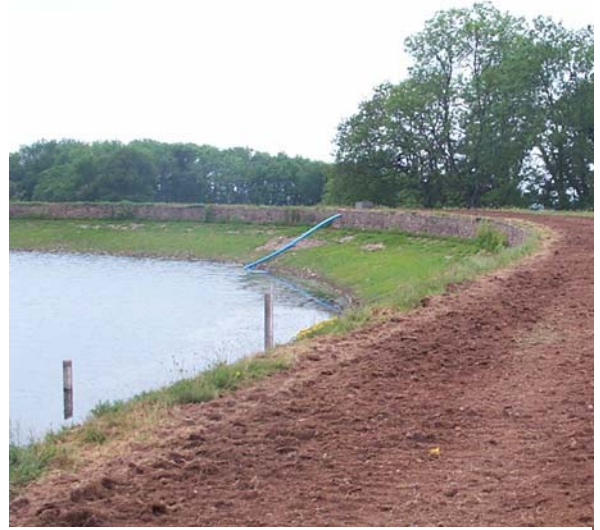
Completed remediation of dam crest
