Embankment Stabilisation

South Milford Embankment

Continuous Flight Auger piled retaining wall for failed railway embankment

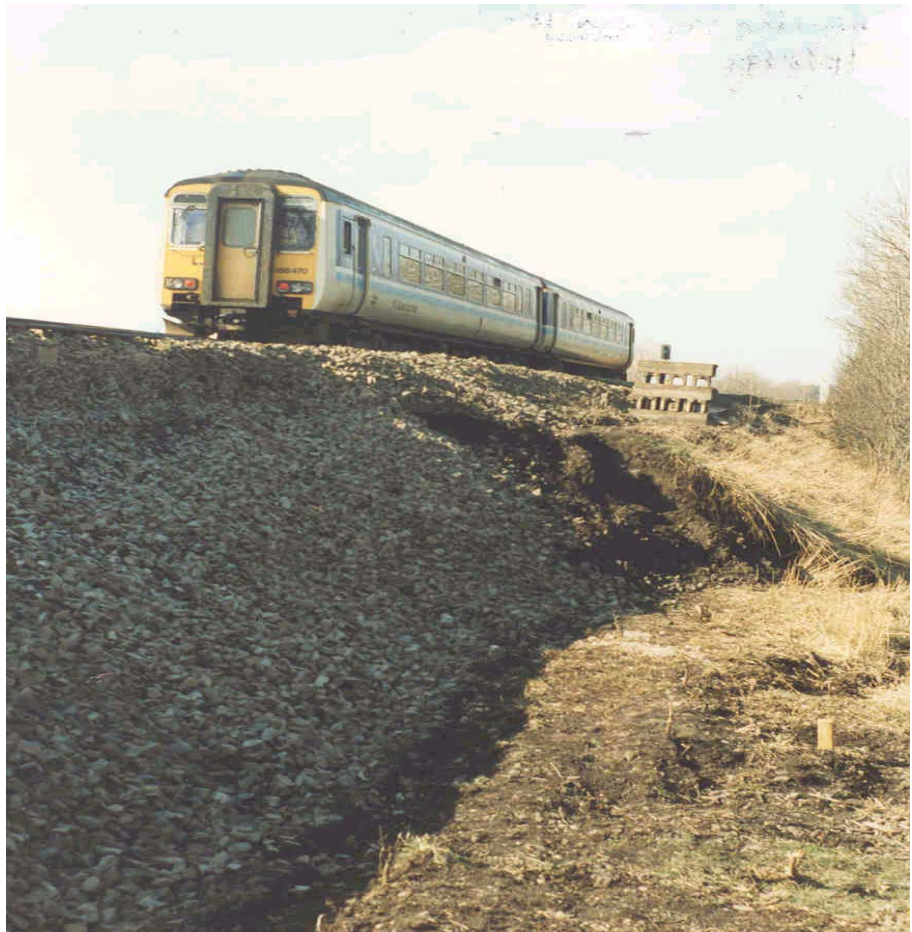
Site of major slip failure prior to commencement of remedial work

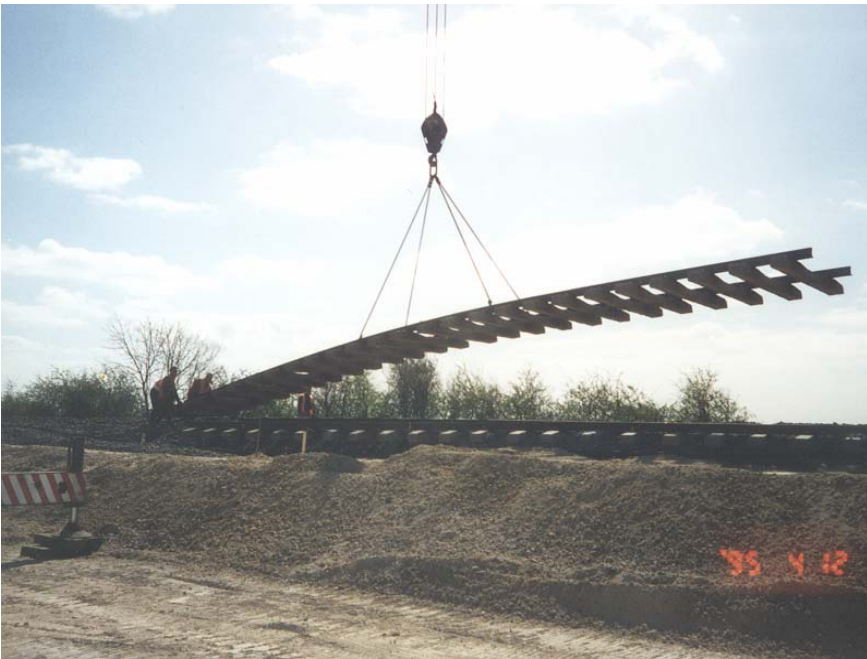
Reinstatement of track onto stabilisation area

Finally, Bachy Soletanche themselves relayed the track under the supervision of Railtrack's Permanent Way Engineer.

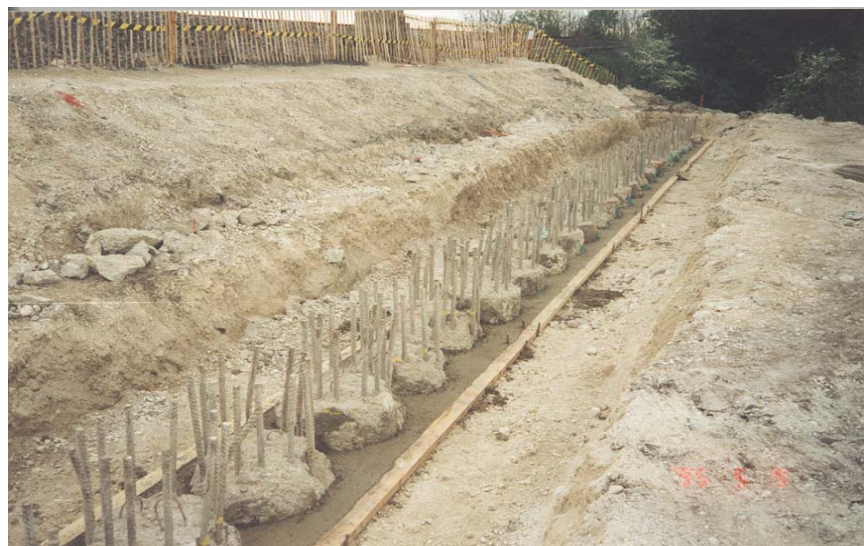
Contiguous bored pile wall construction

A piled retaining wall was installed through the slip plane using continuous flight auger techniques to provide an adequate factor of safety against failure.

750mm diameter piles were installed at 850mm centres to a depth of 14m over a 70m length at a distance of 9m from the nearest track. The piles were reinforced over their full length.
