Slurry Cut-off Wall with HDPE membrane

Derrinumbera

Near Castlebar, County Mayo, Ireland

Mitigation of leachgate migration from existing landfill

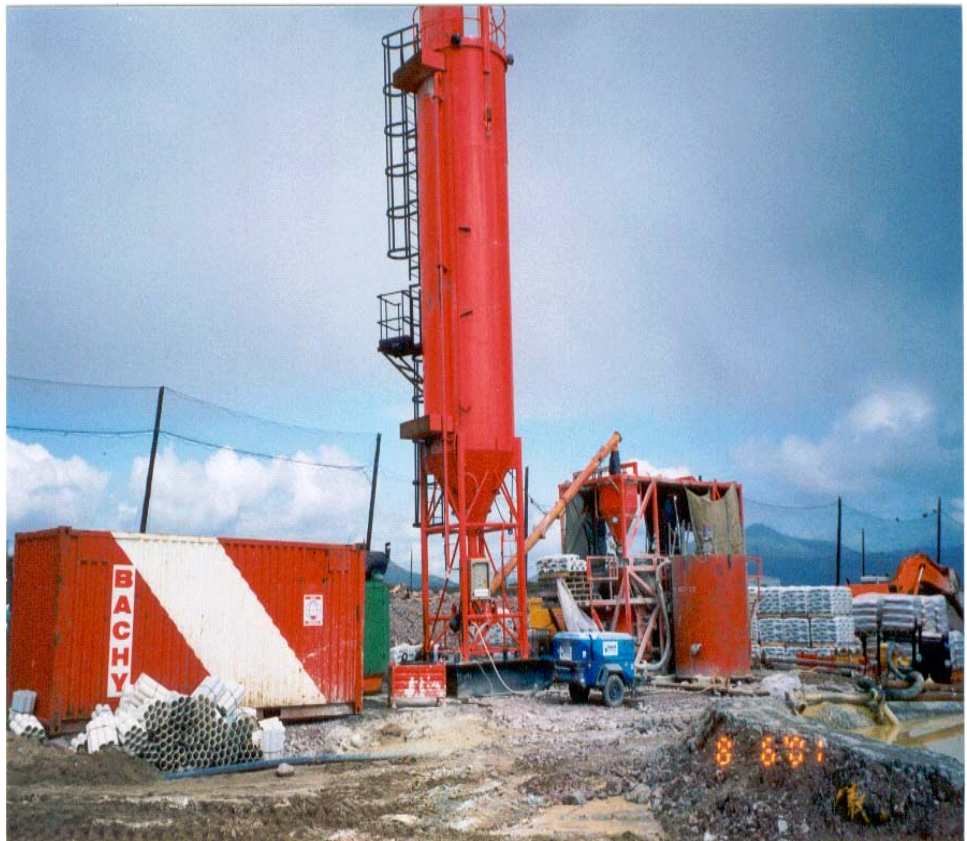
BSL mixing plant area

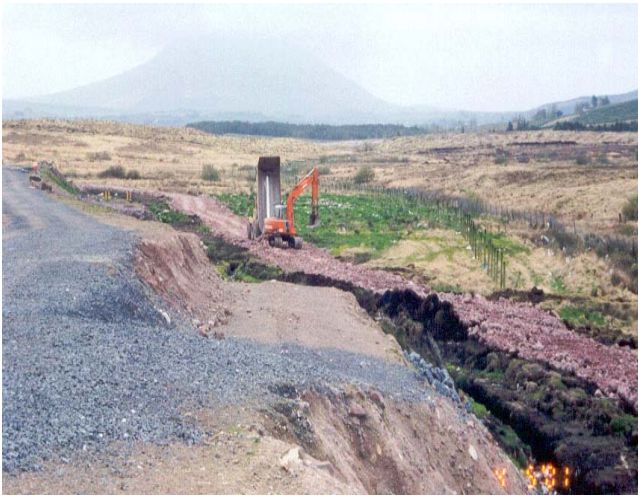
Preparing piling platform

The alignment of the slurry wall meant that a large portion of the excavation was carried out on sloping ground. This posed two main problems; firstly the slurry had to be banded at regular interval to maintain a level profile and secondly a stable platform had to be formed to facilitate the movement of plant (45T excavator, 80T service crane). The type and depth of strata encountered varies as the excavation proceeded. In general though the top 3-4 m of ground consisted of heavy peat which overlaid a narrow clay layer which in turn overlaid weathered sandstone.

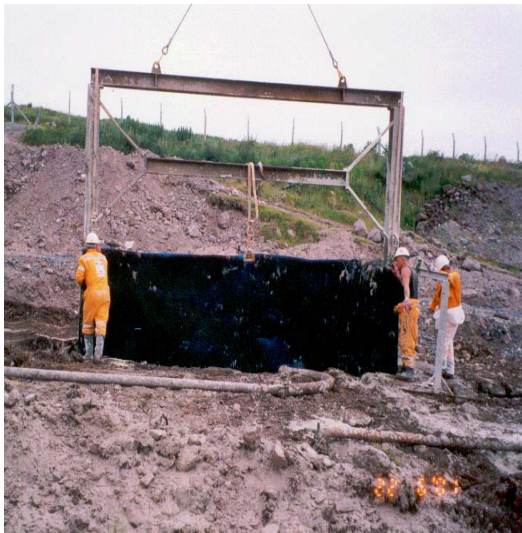
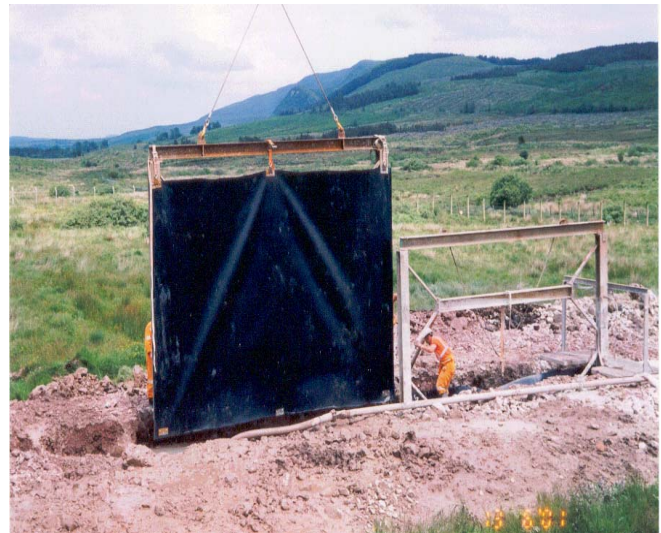
Insertion of HDPE membrane into Slurry Wall

The cut off wall solution was adopted to overcome the problem of refuse leachate migration into salmon rich rivers in the vicinity of the tip. The inclusion of the HDPE membrane enabled the finished wall to act as a barrier against both gas and leachate fluid movement from the tip and into the surrounding countryside.
