Minipiles & Permeation Grouting

Thirlmere Aquaduct, Nab Scar

GRASMERE, CUMBRIA, U.K.

Remedial Grouting and Minipile works to stabilise slope

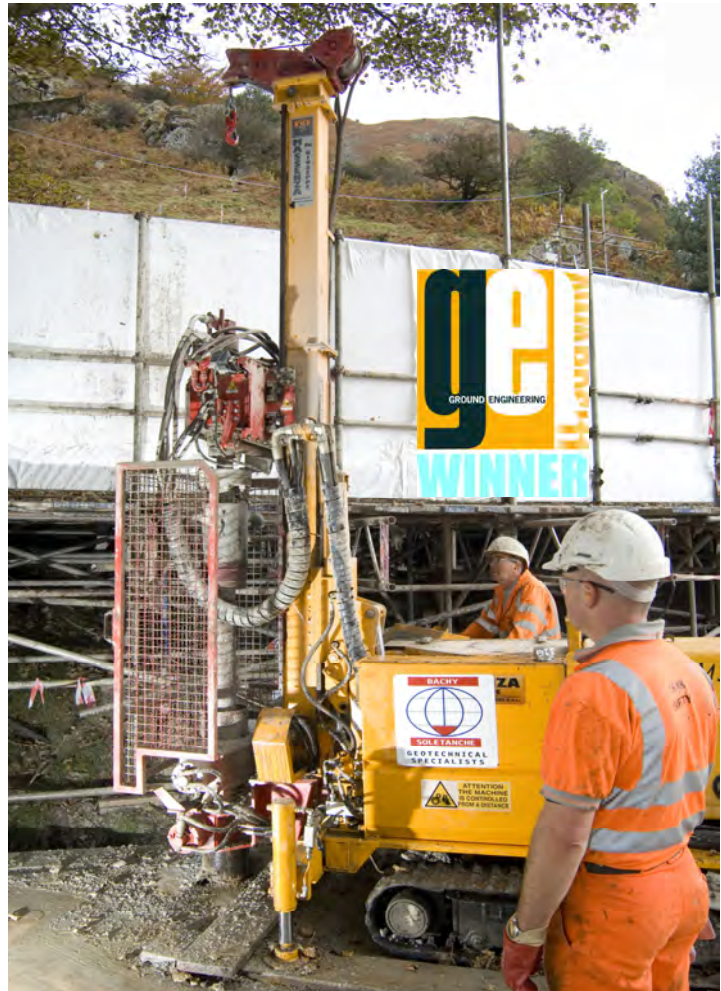
Minipiling on a steep slope

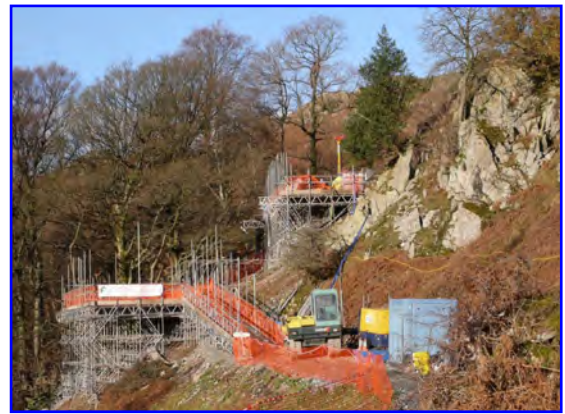
The in-house design used an A-frame pile arrangement with two piles, one vertical acting in compression and one raking, acting in tension. Materials were scheduled in lengths that could be man-handled to facilitate the movement and placement of the components without extensive lifting plant. The selection of a small diameter pile also allowed the use of a light weight rig that could access the steep slopes on the site. Pile caps also needed to be designed so they would quickly blend in to the heath vegetation.

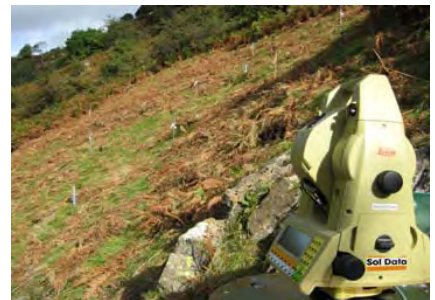
Deep seated movement within the hill slope was recorded via InclinoMeters. Surface movements were monitored via a fully automated, computer controlled total station system that observed prismatic targets. Monitoring of the aqueduct structure, was carried out by precise levelling points, rod extensometers, electro-levels, in place inclinometers, tilt meters and crack width gauges.

During the piling works, care had to be taken to ensure that no site work would cause further movement of the ground surrounding the aqueduct and/or damage it. Real time movement monitoring was carried out by our sister company & monitoring specialists, Sol Data.
